River Ecosystem Restoration: In Perspective to Turag River

Field of Research: Environmental Engineering

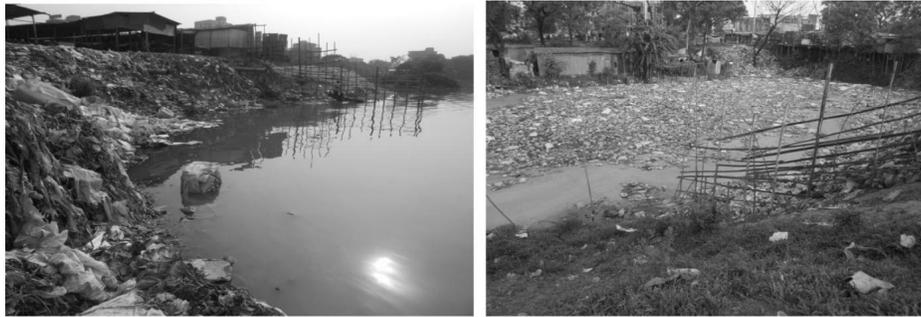
Figure 1: Garbage and Waste Dump into the Water Near Abdullahpur and Tongi

The water of the Turag River is so polluted that it is hindering the preservation of ecology in the capital city. Alam (2016) discussed in his report about millions of gallons of raw wastewaters that coming from manufacturing houses on a regular basis are being discarded in the rivers around Dhaka city through almost 185 outlets. He mentioned, nearly thirteen openings discharge untreated industrial wastewaters in the Turag and the Balu between Tongi Kamarpara and Isapur. Alam (2016) further observed, during the Bishwa Ijtema which is a big religious gathering for Muslim pilgrims coming from all over the world stay by the riverside for several days. As proper accommodations and adequate sanitation systems are lacking greatly, human wastes and garbage generated at the site are being disposed into the river shown in figure 1. As a result, river water gets polluted and the ecosystem is negatively impacted.

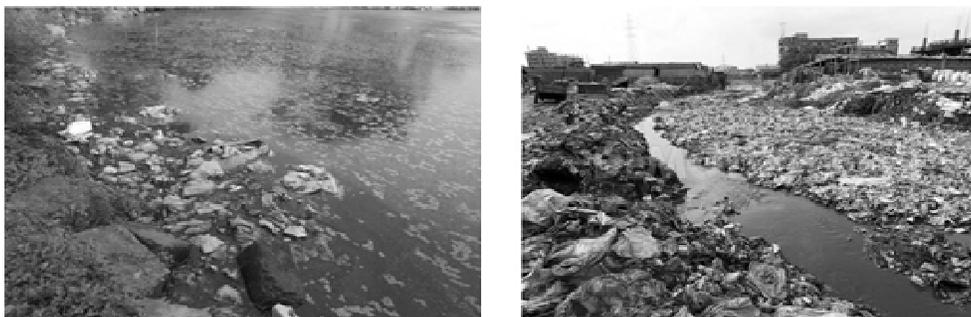
Figure 2: Chemical Waste and Garbage Disposal has Stagnated the Water and Turned Blackish

Banu et al (2013) pointed out recent findings on potential polluted site which includes Buriganga Third Bridge area at Basila and the Tongi Bridge area, shown in figure 2. These contaminated water is pitch black colored and has strong odors. Therefore, the water cannot be used for any purposes. Hossain (2011) found zero level of Dissolved Oxygen (DO) at both of these sites for almost round the year except during the monsoons when the river is full. According to the Environmental Quality Standard (EQS) complied in Bangladesh, DO level required for drinking, recreation, fish and livestock, industry and irrigation are 6 mg/l, 4-5 mg/l, 4-6 mg/l and 5 mg/l respectively. The Biological Oxygen Demand (BOD) level tolerance is 0.2 mg/l, 3 mg/l, 6 mg/l and 10 for drinking, recreation, fish and for irrigation respectively. But according to a study carried out by Hossain (2011), the BOD level of the water at these two points is close to zero, which is not safe to use. Similarly, other parameters of water quality like TDS, TSS, TS, Turbidity, Conductivity, COD, pH, Cadmium, Copper, Zinc, and Lead have gradually obtained such statistics that have already exceeded the limits of appropriateness.

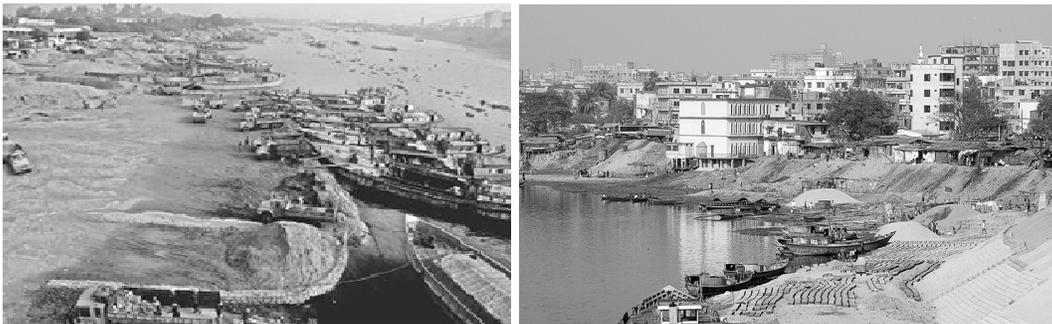
Figure 3: Encroachment of River by Sand Traders and Brickfield Owners

Mahmud (2014) stated that river land grabbing and encroachment are the major problems at the Turag River site. Alluvial rivers like Turag, Buriganga, and Shitalakhya are good sources of fine grade sand. To compete with the recent development of Dhaka city, sand traders have invaded the river banks, shown in figure 3, to extrude sand from the river bed neglecting all the rules and regulations issued by the High Court of Bangladesh. As a result, some areas of the river have been dried up and the river channel has changed.

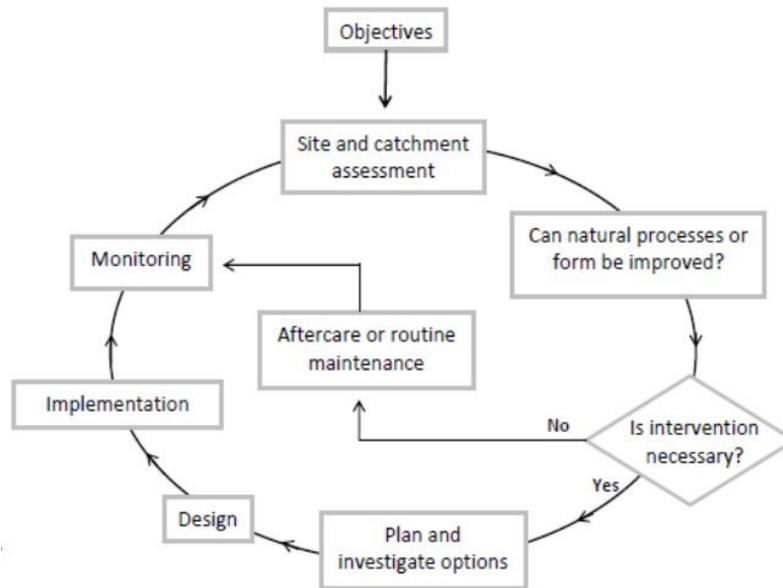
Figure 4: Management Cycle of River Restoration Method (Be, Know, Do: Manual of River Restoration Techniques, 2013)

There is a sequence of activities to plan, design, implement and subsequently manage the restoration works. This sequence is defined in figure 4 that shows how the river restoration processes can be managed in a systematic way.

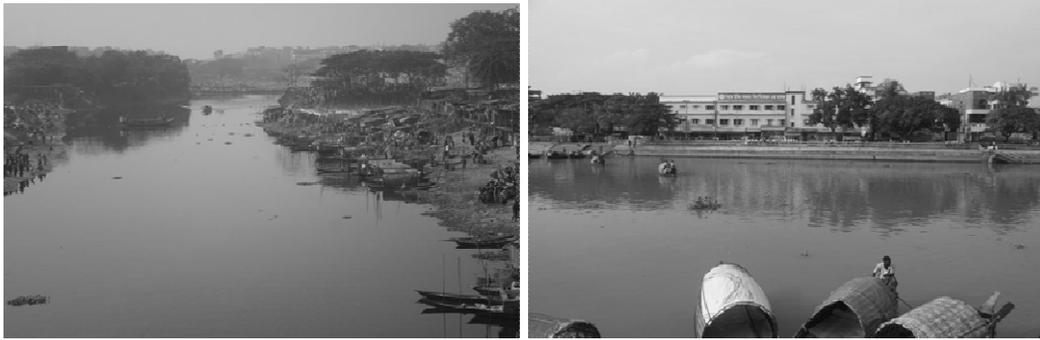
Figure 5: (A) Typical Low Flow Period of Turag River in December to February (Left); (B) During High Flow Pulse after Few Days of Rain in the Month of August 2015, the Watercolor has Drastically Changed from Blackish (Right)

The above flow components are again quantified with some variables which determine the flow characteristics and time. Magnitude, Timing, Duration, Frequency, Rate of change. The environmental components associated with environmental flow management are easily applicable to Turag River as the flow pattern, the catchment area is still in good condition. Naturally, due to the pollution, waste dumping, and illegal land encroachment the water flow is very low which can be seen in figure 5.

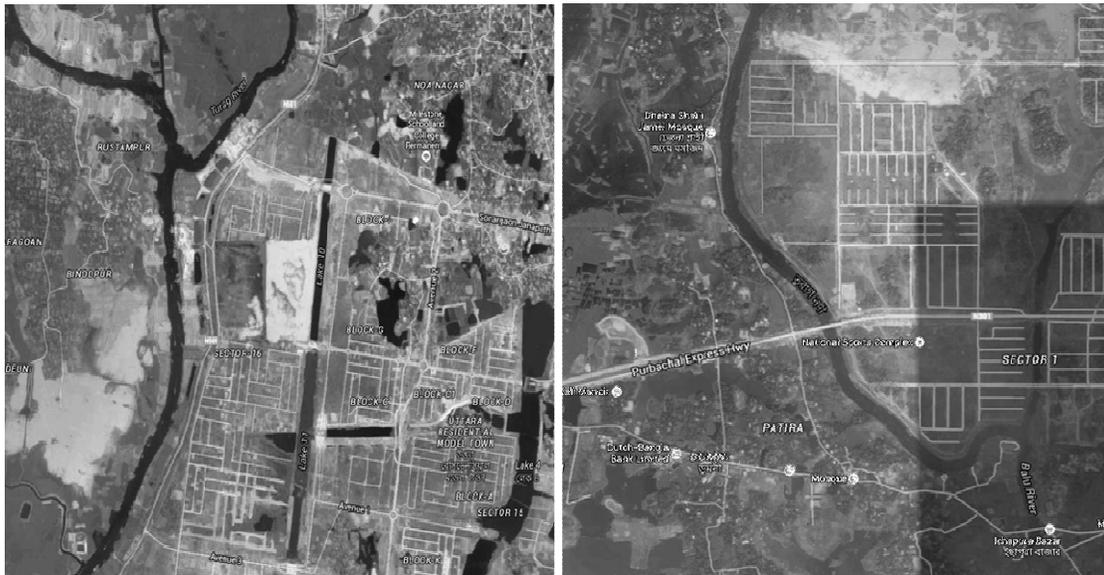
Figure 6: Satellite Image for Turag River Flow Path. (a) North-West of Dhaka Near the Uttara Residential Model Town (Left), (b) North-East of Dhaka Near the Purbachal New Town (Right)

The figures 6 (A) and 6 (B) shows the flow path of the Turag River around Dhaka. Close observation shows that the river lining has spaces on both sides where tree plantation can be practiced in order to develop a riparian ecosystem. If such long ecosystem is established, it will be beneficiary for both the river health quality as well as for the newly developed residential areas, Uttara Residential Model Town and Purbachal New Town.

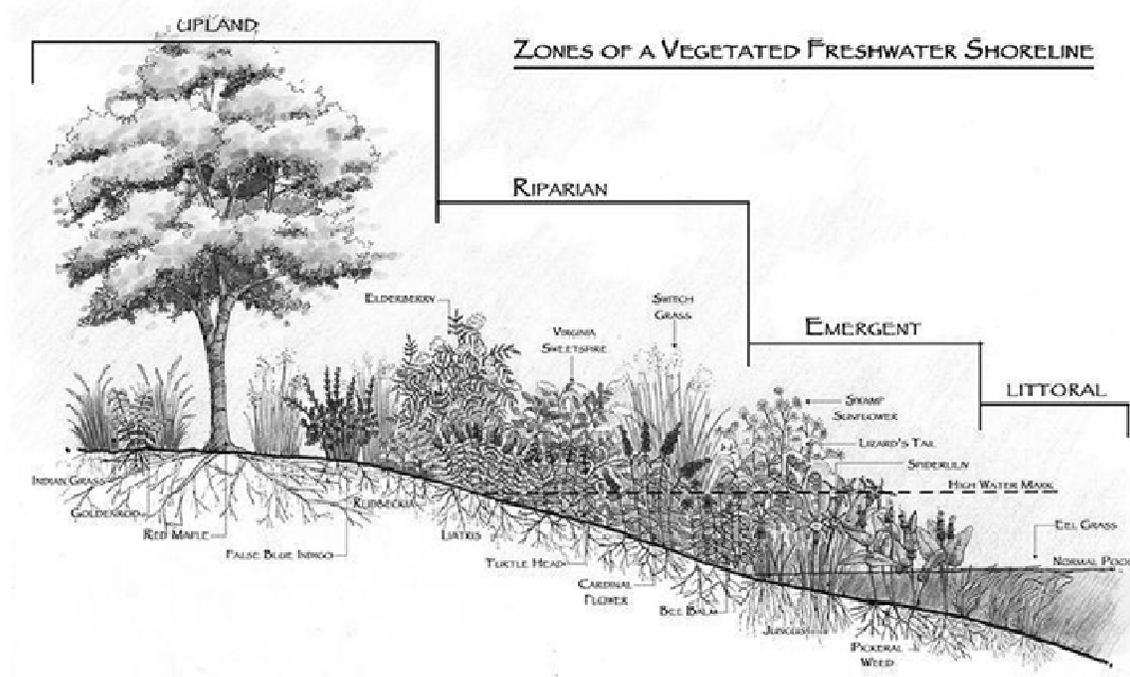
Figure 7: A Conceptual Diagram of the Riparian Ecosystem (Be, Know, Do: Aquatic Ecosystems, 2017)

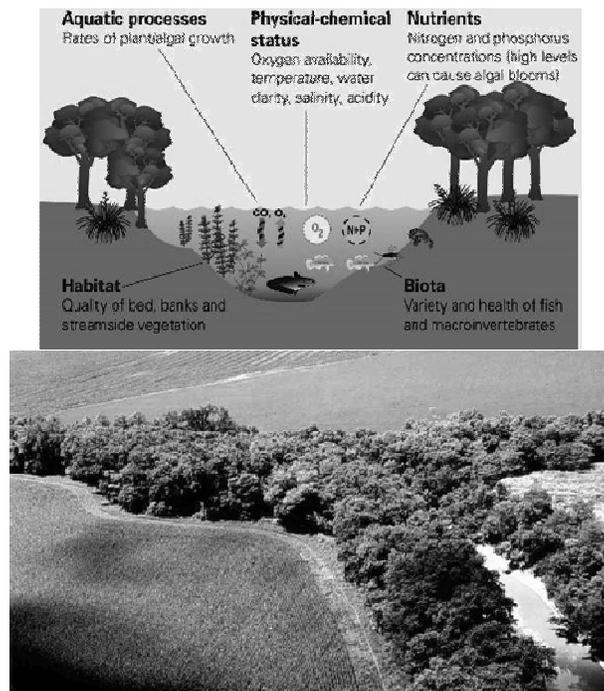
Figure 8: (a) The Biological Process That Takes Place in the Riparian Ecosystem; (b) Lake Erie, 4th Largest Lake in North America is preserved with Riparian Tree Cultivation

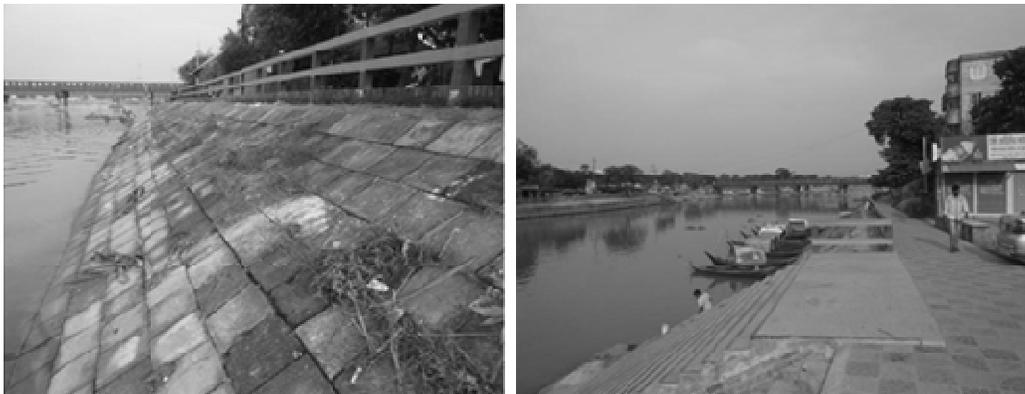
Figure 9: Newly Established Embankment with Concrete Slabs and Long Clean Pavement from Abdullahpur to Kotbari Bazar

- Setting up boundaries along the channel alignment (figure 9)
- Erecting tall fencing to prohibit dumping of any solid wastages and garbage
- Sealing the river bank permanently with pavement slabs
- Dredging of critically narrow and shallow river bed near the Estama Field
- Proper action against land encroachers
- Seal all the pipelines coming from cities/town sewerage and industries
- Implement existing law and regulations
- Removal of illegal residential and industrial buildings from the bank of the river
- Establish an effluent treatment plant (ETP)
